# TECHNICAL PAPER – TP 002

## Issues with Determination of Adhesive Bed Coverage

### Stack Stone Glue and Mosaic Mesh Adhesive

TP002.005

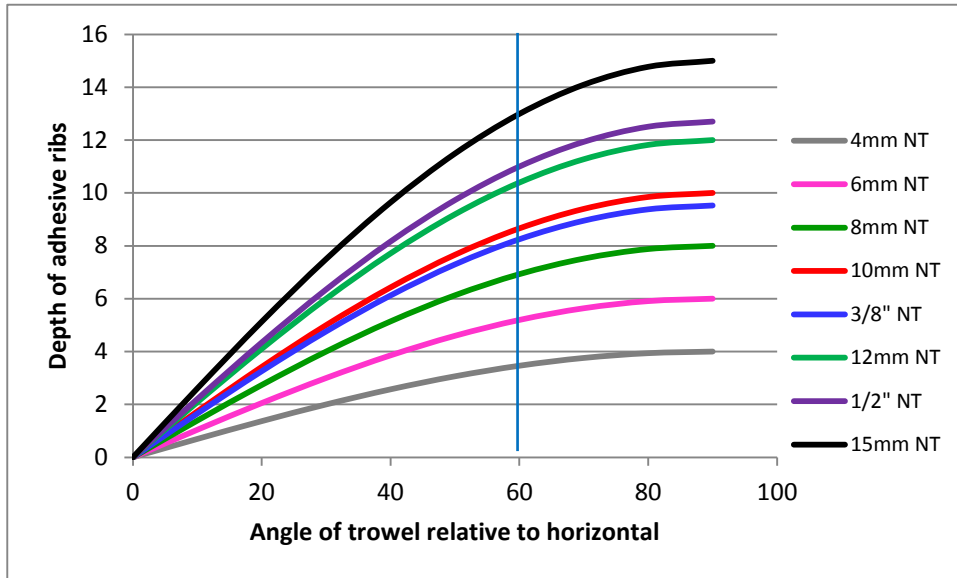
Graph 1. The empirical depth of the adhesive notch ribs in mm is shown above for a range of notch trowel sizes. The recommended angle is 60° to the horizontal; angles above this make little difference, but below the final bed thickness and width will be compromised.

This problem is also interlinked with the bed thickness as too thin a bed will also result in poor coverage. The initial thickness is function of the size of the notch trowel, and also the angle of trowel attack to the surface (relative to the horizontal). The suggested angle is 60° from the horizontal, but it is not unusual for it to be less because it is easier to swing the trowel at lower angles, and also because it increases the adhesive spread rate and makes the job pseudo cheaper. The next three graphs show empirical calculations for the nominal adhesive thicknesses expected. The first shows a range of trowels, whilst the other two are specifically related to a 10mm notch trowel.

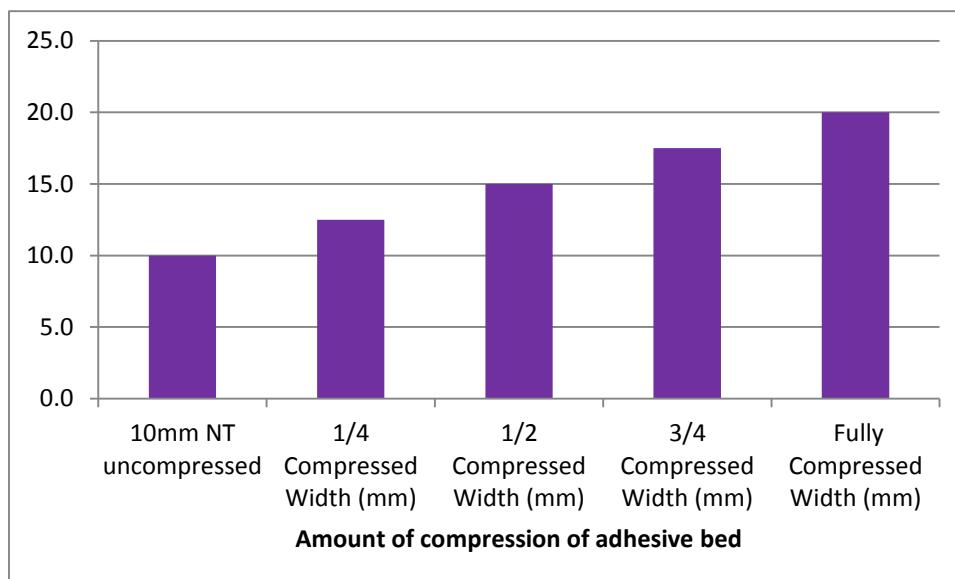
Graph 3. The empirical width of the adhesive notch ribs in mm is shown above for a 10mm notch trowel typically used for floors and heavy larger format tiles on walls. The individual bars refer to how much the adhesive ribs have been flattened, which is a function of the amount of pressure used to lay the tiles.

The recommended trowel angle is 60° to the horizontal and the suggested degree of compression is to achieve full flattening down for a final 100% coverage, but not overly squeeze the adhesive such that it is lost out the sides.

Using these criteria the empirical final bed width for a 10mm notch comb adhesive bed, fully flattened would be in fact continuous, however there are normally faint lines which show each rib has been flattened to ~20mm wide.

The centre to centre distance for tooth/void of the trowel is fixed, so the line width on a tiled bed gives a clear indication of both the degree of flattening, but also the actual type of trowel that was used.

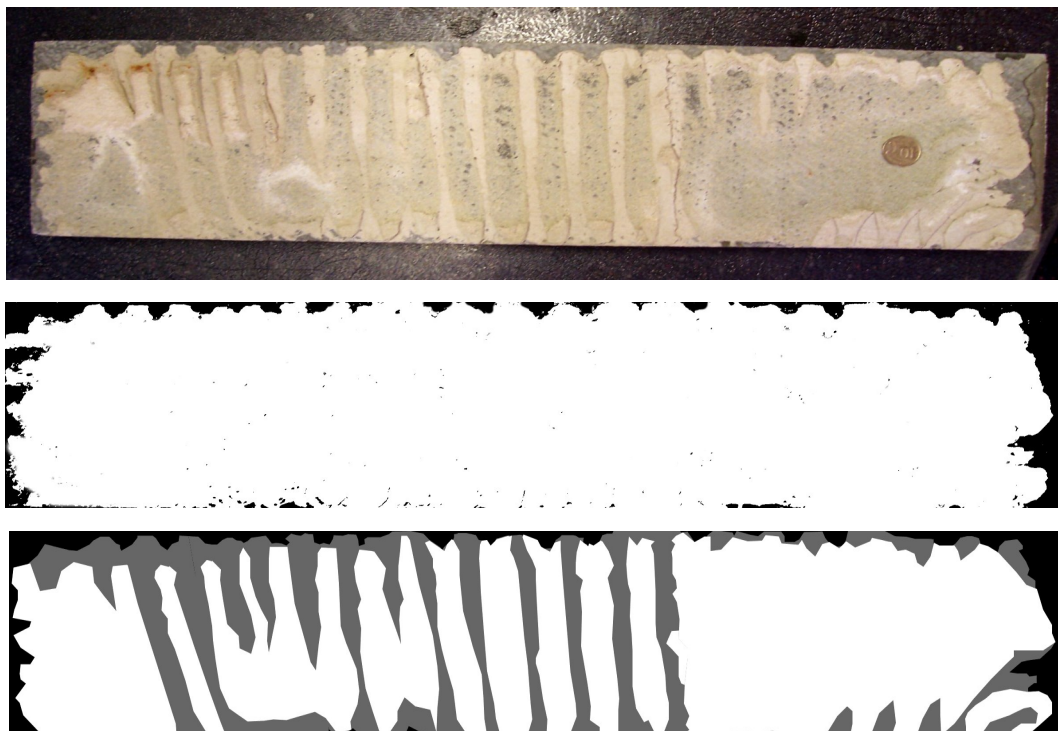
Figure 8. An example where the apparent coverage is significantly higher than the true coverage. At first sight the coverage on this tile appears to be high, and indeed the back surface of the tile has a layer of adhesive on it that covers 93% (second picture). However closer examination shows that the actual coverage of adhesive between the tile and substrate is really restricted to the notch trowel ridges and is closer to 65%. Traces of the adhesive (shown in grey in the third picture) are only a thin layer on the tile itself, do not reach the substrate and so do not contribute to the bond strength.

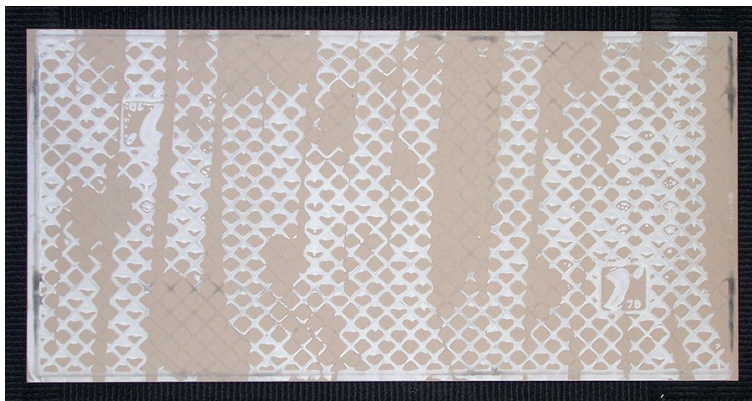
Figure 18.

Tile blocking agent on the back of a tile. Coverage is around 50%.

Tile wash or anti blocking/mould release compound is an alumina-silicate material which is applied the back of tiles during their processing, to prevent the tiles sticking together. It is typically a bright white powdery material which fairly easily rubs off the back.

The powdery material can act as a bond breaker and lead to the adhesive coming off the back of the tile. This material should be removed, and this means either scrubbing it off or using a wire brush on a drill or grinder to remove it. The recommendation is that it should not cover more than 15% of the tile back face.
