LABORATORY MEASUREMENT OF THE REDUCTION OF TRANSMITTED IMPACT SOUND OF CERAMIC TILES ON AN UNDERLAY SYSTEM

Test report ID: T1933-2
Report prepared by:
Mr Gian Schmid
Dr Andrew Hall

LABORATORY MEASUREMENT OF THE REDUCTION OF TRANSMITTED IMPACT SOUND BY FLOOR COVERINGS ON A STANDARD FLOOR

ARDEX New Zealand Limited
15 Alfred St, Onehunga,
Auckland 1061, New Zealand

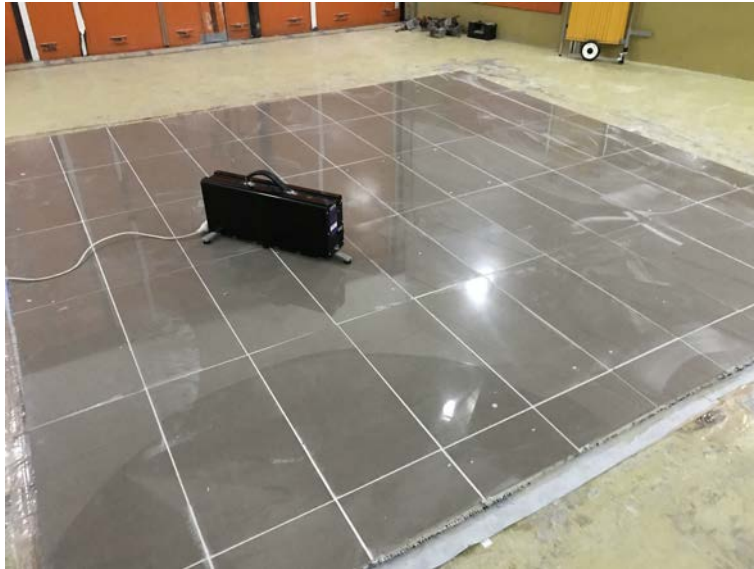
Figure 1.1: Sample system ready for testing

- Layer 1: ARDEX WA 98 A, Solvent-Based Contact Adhesive
 - Layer 2: ARDEX WPM 1000, WeldTec External Undertile Waterproofing Membrane
 - Layer 3: ARDEX UD 150, Thin Layer Undertile Drainage Mat (loose lay)
 - Layer 4: ARDEX Quickbond, Quick Setting Tile Adhesive (10mm notch rect trowel)
 - Layer 5: Full body porcelain tile, 10mm thick
 - Layer 6: ARDEX FG 8, Flexible Coloured Grout for Joins 1-8mm
 - Layer 7: ARDEX SE, Flexible Acetic Cure Silicone Sealant
- Dimensions:** 3.2x3.2m
Placement: Directly on chamber floor

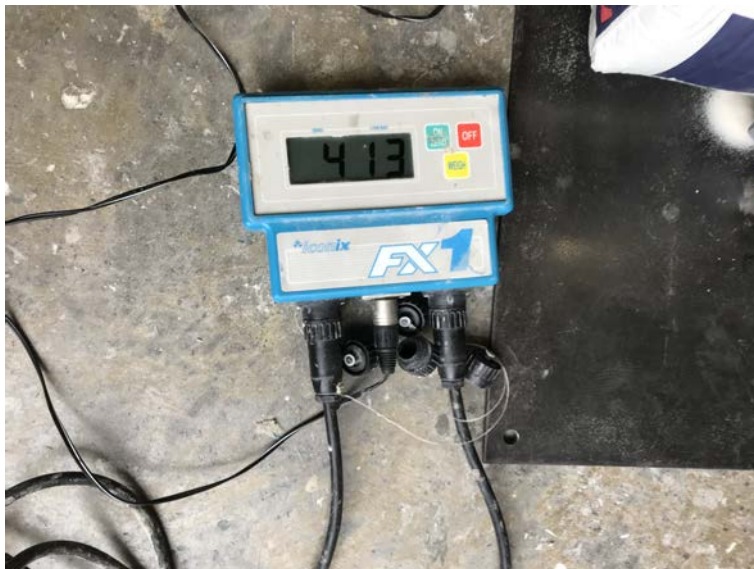
Figure 1.2: Total weight of sytem

Mass per area: 40.33 kg/m²
 Air temp in the test rooms: 22 °C
 Air humidity in test rooms: 59 %
 Receiving room volume: 153 m³

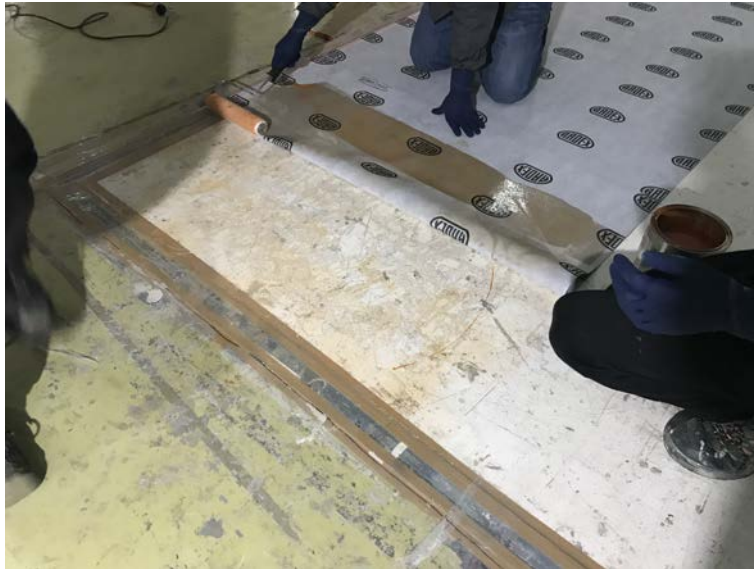
Figure 1.3: Installation of waterproofing layer ARDEX WPM 1000

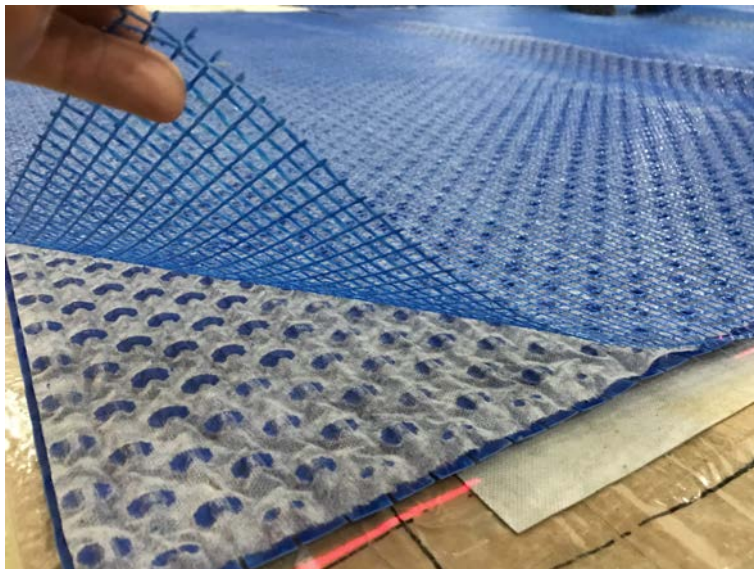
Figure 1.4: ARDEX UD 150 and ARDEX WPM 1000 underlay

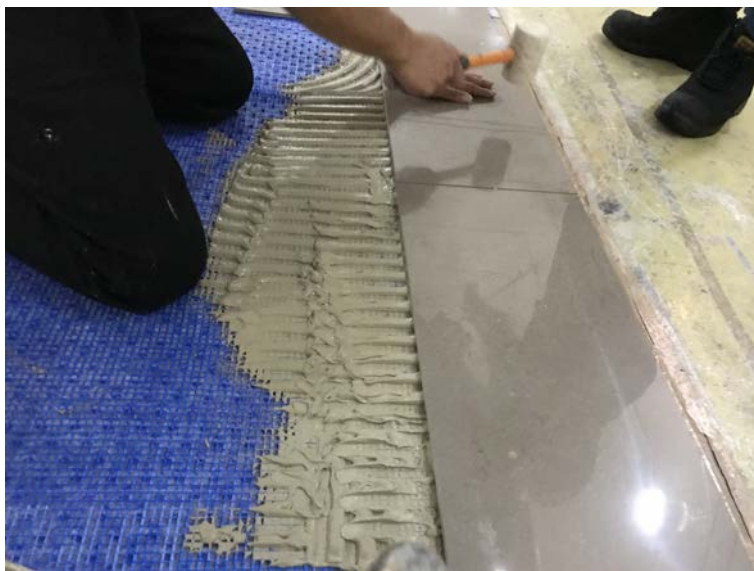
Figure 1.6: Installation of tiles
